CHECK-OUT REPORT

Check-Out Details:

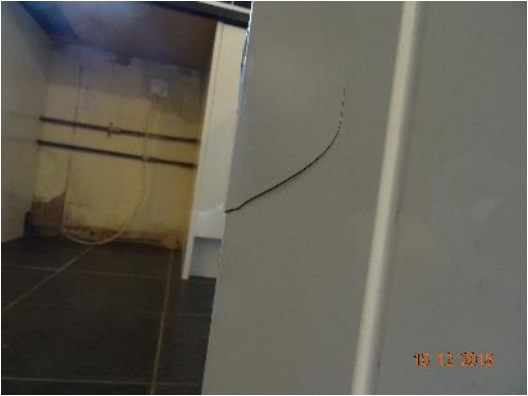
Facing wall	FWT	Occasional light grubby mark to $\frac{3}{4}$ height
	Hand basin	FWT	Small amount of movement in cold tap upon use
Reception room	Ceiling light	NW (2)	Was 1 bulb now 2 bulbs not working
	Coving	A	2 tacks added to the facing wall
	Flooring	INFO	Requires cleaning - due to poor light and dark colour of carpet difficult to assess fully although assumed will be improved sufficiently with cleaning as no heavy or specific marks or damage currently evident
	Back wall	FWT A	Occasional very light mark to the mid and lower level 1 small bent nail
	Back wall radiator	FWT	1cm flake to lower right of front
	Left hand wall	INFO FWT	Section of paper no longer missing to the right hand corner 3cm paper rub to the lower right
	Left hand wall light	NW/M (3)	Both bulbs missing
	Facing wall	INFO A	1 nail and 1 small hole now 2 small holes, cream painted batten with previous fixing holes still present over both doors Double satellite cable now coming through to lower right of double doors to garden

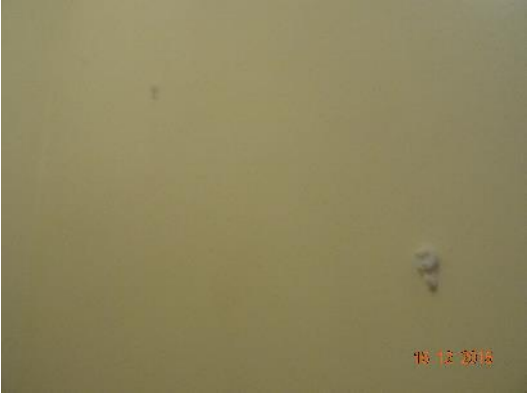
MAINTENANCE REPORT			
Room	Item/Area	Type (Ref)	Comments/Findings
	Miscellaneous	M	Unable to locate used roll of wallpaper, Virgin Media wireless router box with cables, and Virgin Media receiver box with power lead and controller
Stairwell	Walls	FWT	2 shallow indents over 1 st picture hook, slightly heavier scuffing and paint rubbing in 5 areas to half landing mid-level
		A/D (4)	8 picture hooks and 4 small holes added (excessive for wall area)
	Skirting	FWT	1cm surface chip and 1.5cm flake to right of tread 2
	Flooring	INFO	Carpet requires cleaning – assumed will be improved sufficiently once cleaned
	Woodwork	FWT	Newel posts and particularly 2 sections of hand rail would benefit from repainting soon
Landing	Smoke detector	INFO INFO	No longer detached from bracket Tested with button and sounding at time of check-out
	Light pendant	NW (5)	1 of 2 bulbs not working
	Skirting	FWT	Lightly rubbed to left of airing cupboard

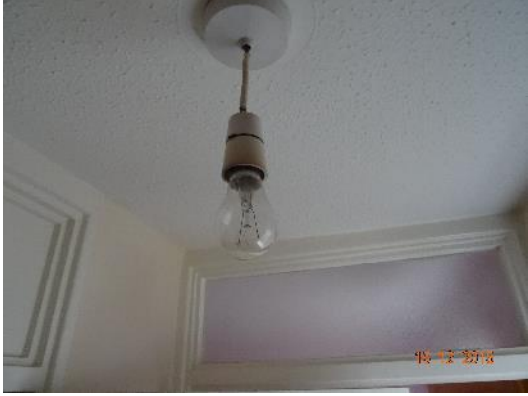
Flooring	INFO	Requires cleaning – assumed will be improved sufficiently once cleaned
	Door to cupboard 1	A (6)	Toilet brush, bag containing blue and red Lilo type item, red bucket containing miscellaneous sheet, shower curtains and weighing scales - all now in cupboard
	Door to airing cupboard	FWT M (7) A (8) M	Internal flooring with 2.5cm white mark to the right side Bulb missing from internal light rose Interior now with 3 flattened cardboard boxes and pair of crutches 6 used light shades, pair of shoes and roll of wrapping paper - no longer to interior
	Facing wall	FWT	Now with occasional light scuff and grubby mark to ¾ height
	Window	INFO	Key returned with property keys
	Door to bathroom	FWT	4.5cm surface scratch to upper left of door
Bedroom 1	Light shade	A	3 section chrome framed shade with numerous hanging crystal effect beads now present – appears sound and complete
	Flooring	FWT D (9)	Existing fraying and gapping at door to landing now in area 3cm x 70cm 3.5cm diameter residue mark between centre and cupboard with black residue spots in area 4cm x 3cm between centre and left hand wall
